A Little on LIF

SINGARS...

Cop a Dust Cap

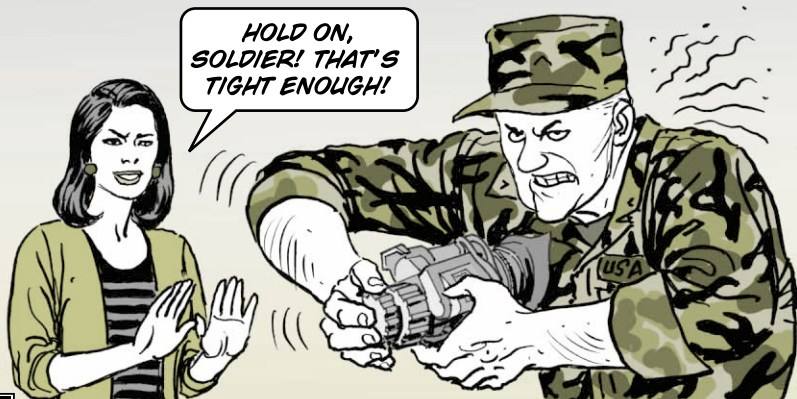
If you overtighten the light interference filter (LIF), NSN 5855-01-379-1410, you can crack the objective lens on your AN/PVS-14 night vision device.

The problem is excessive muscle when you use the LIF container wrench.

Even though you're given a wrench to use, the LIF should be tightened only hand tight. That means when the filter is in place and secure, stop tightening!

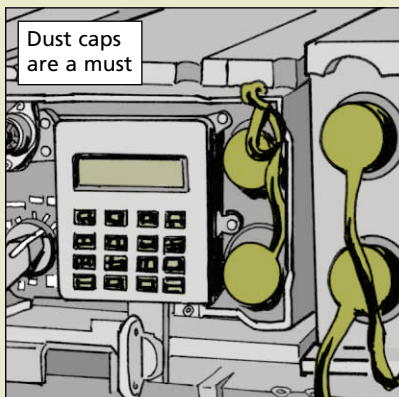
The advanced SINGARS improvement program (ASIP) E-model receiver-transmitter has been doing its commo job for long enough now that a few dust caps are coming up missing.

Here are four dust caps and their NSNs that you might need to replace:

Location	NSN
Back of RT	5340-01-462-0317
RT/Aud Fill	5340-01-346-4291
Aud/Data	5340-01-346-4291
GPS on VAA	5340-01-357-2333
